Plugging the gap: Aotearoa's piped water loss far worse than global leaders

21 January 2025

Nick Wilson, John Kerr, Adele Broadbent, Michael Baker

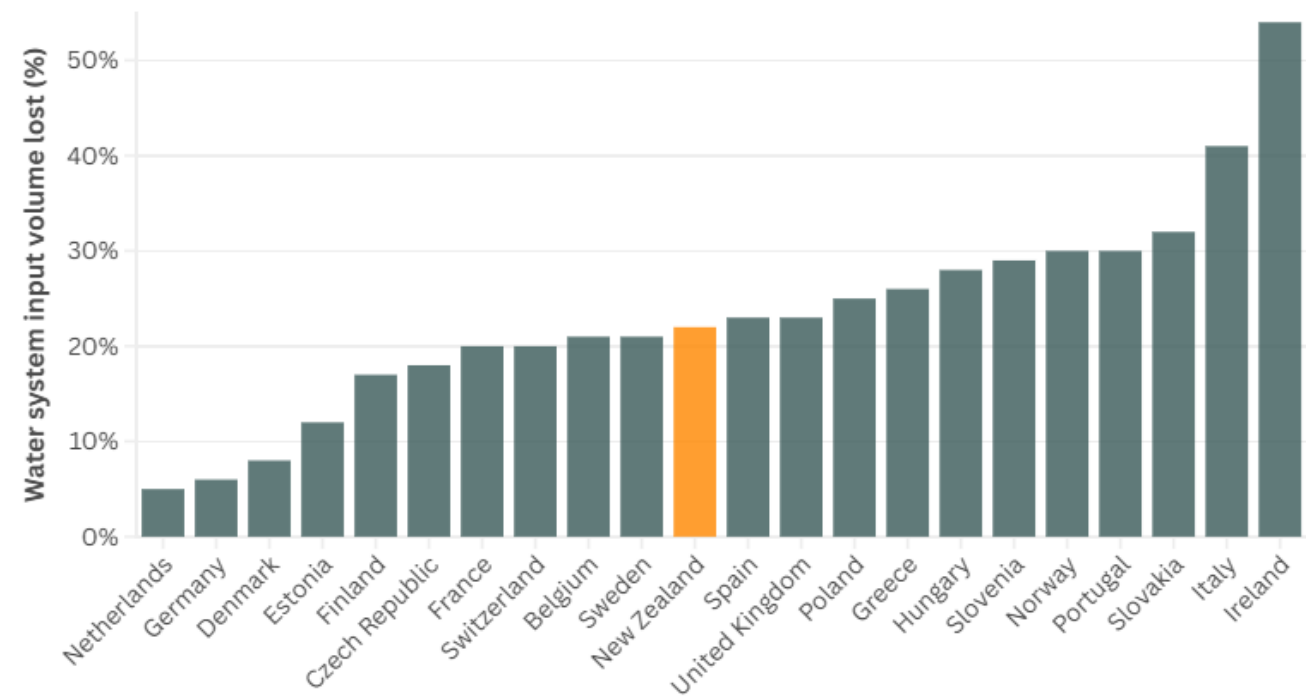
Figure 1. Water system leakage data for NZ and European countries in the OECD

Source: EurEau (2021) • NZ national estimate (22%), reflects 133 million m³ loss out of 596 million m³ supplied (calculated from the online data in Taumata Arowai 2022/23 report⁵)

[Figure 1](#) gives water leakage results for OECD countries in Europe along with NZ. It shows that NZ performs better than the median country in this group, but is still far worse than the Netherlands (5%) and Germany (6%). Also, the NZ national 22% estimate obscures some particularly poor locality results eg, Upper Hutt at 41% leakage,³ and South Wairarapa at 42%.⁴

But using leakage data based on the percentage of water system input volume lost as in [Figure 1](#) is fairly crude. That is because this measure is “influenced by consumption and does not take into account the factors of supply continuity, mains length, number of service connections, location of customer meters, and average operating pressure”.⁵ A more appropriate metric is the “Infrastructure Leakage Index” (ILI) with OECD jurisdiction comparisons shown in [Figure 2](#) (Table A2 in the [Appendix](#)). These comparisons suggest that NZ is a relatively poor performer (median ILI of 2.7 for the largest water suppliers), and it is ranked near the bottom of a list of 15 jurisdictional groupings with ILI data. For example, the ILI for the Netherlands is 0.6 and for Denmark it is 0.7 (Table A2). Furthermore, the “Wellington Water network reported the highest ILI of urban networks at a value of 5.2.”⁶ These figures are consistent with Taumata Arowai documenting many pipelines that are in “poor or very poor condition”.⁶

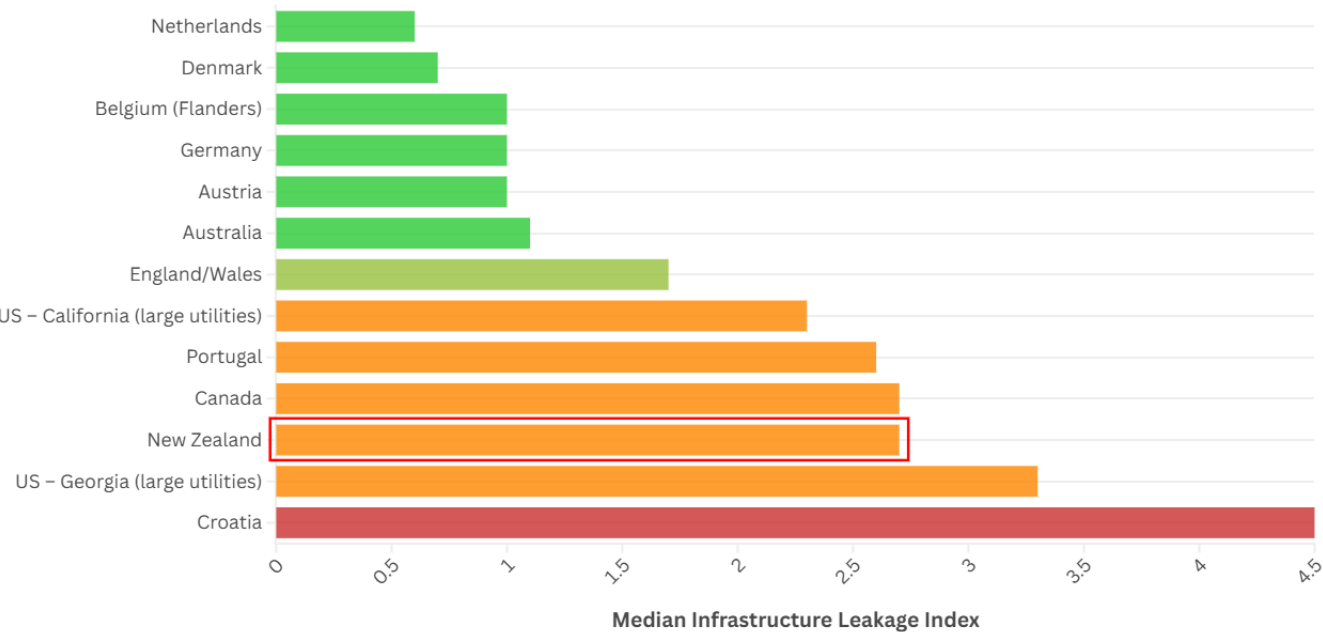
Figure 2. Infrastructure Leakage Index values

Median Leakage Index: ■ Very low ■ Low ■ Moderate ■ High

Note: See Table A2 in the Appendix for extra details and sources.

Leaking water system infrastructure in Aotearoa New Zealand (NZ) poses risks to public health and wastes precious public funds—estimated at around \$122 million per year. In this Briefing, we estimate NZ’s national leakage level, finding that 22% of water is lost through leaks in water systems. This is far worse than leading European countries such as the Netherlands (5%) and Germany (6%). A more sophisticated metric (the Infrastructure Leakage Index), also suggests NZ is ranked near the bottom of a list of 15 jurisdictional groupings with data (the median index score for NZ is 2.7 compared to 0.7 for Denmark).

A particularly impressive low leakage result was achieved by the former Waitakere City Council (now part of Auckland Council). Through a number of initiatives and management practices over an 18-year period, it “achieved and maintained an Infrastructure Leakage Index of close to 1.0”.¹⁵ This is nearly as good as that for the Netherlands and Denmark (Table A2).
